Demolition in Urban Environment

The Asian Trade Centre Case – an accident occurred in a demolishing building in Yau Tong on 29 Nov 2001

Presented by
Raymond Wong

Division of Building Science & Technology

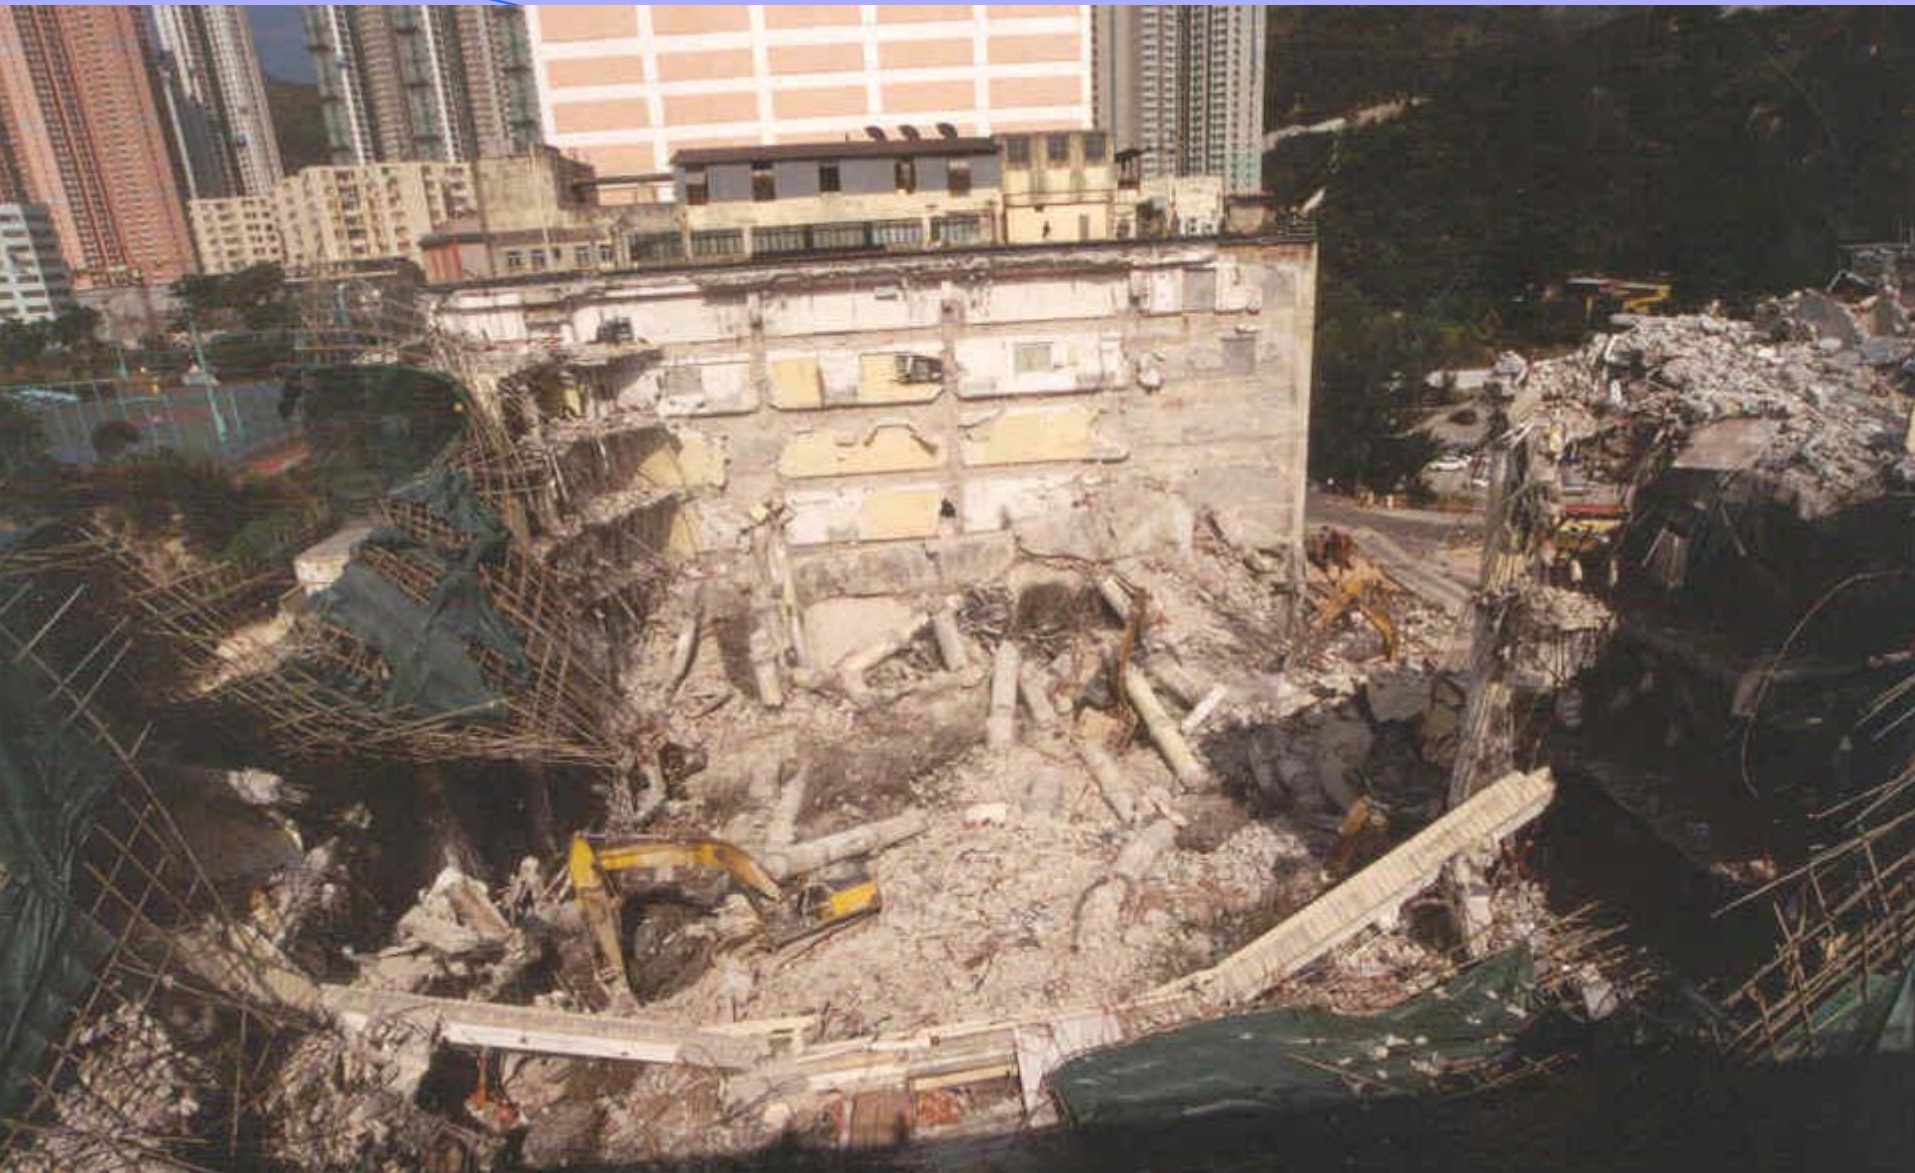
The site as seen after the collapse on 30.11.01 (viewing north)

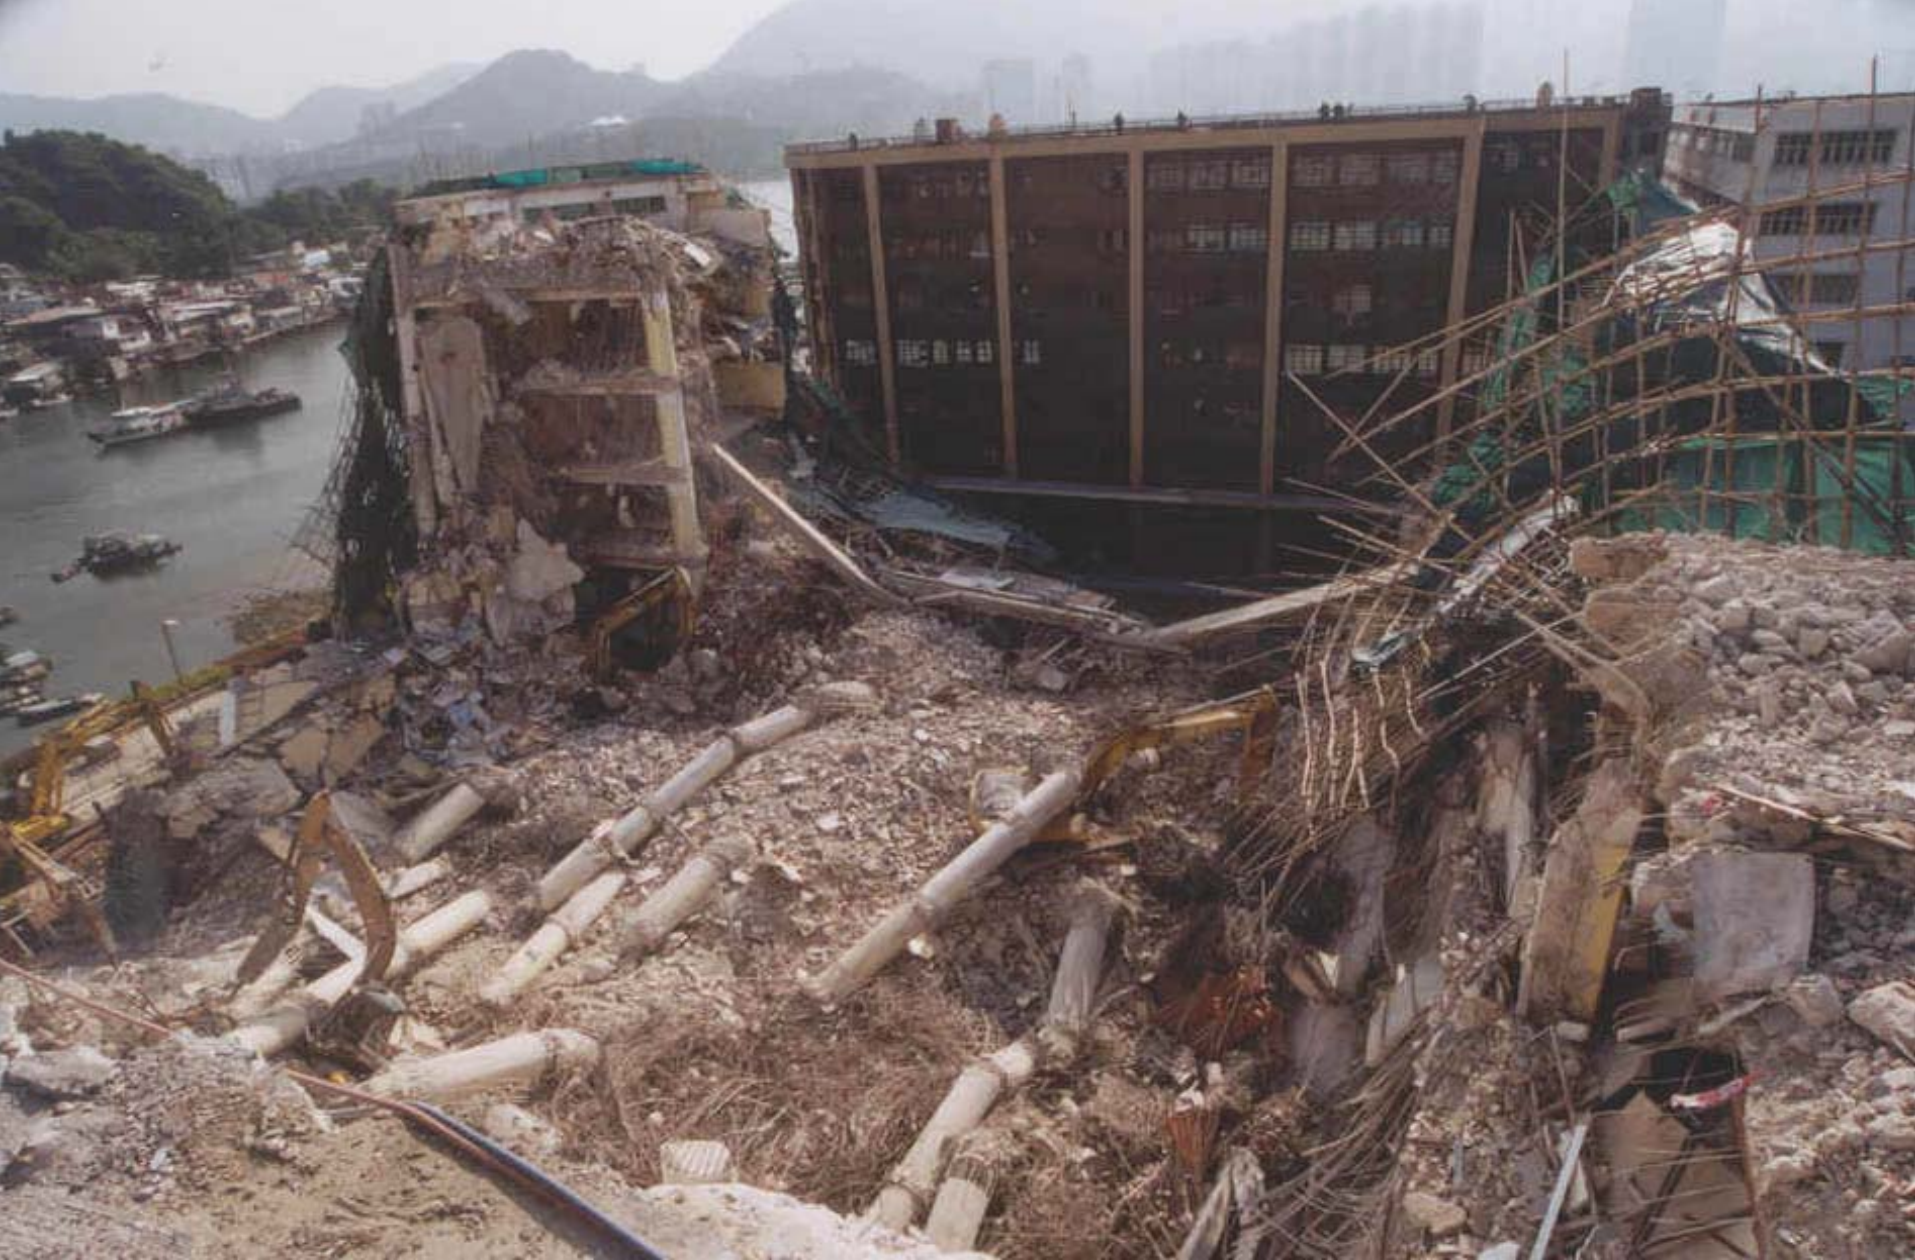
The site as seen on 30.11.01 (viewing south)

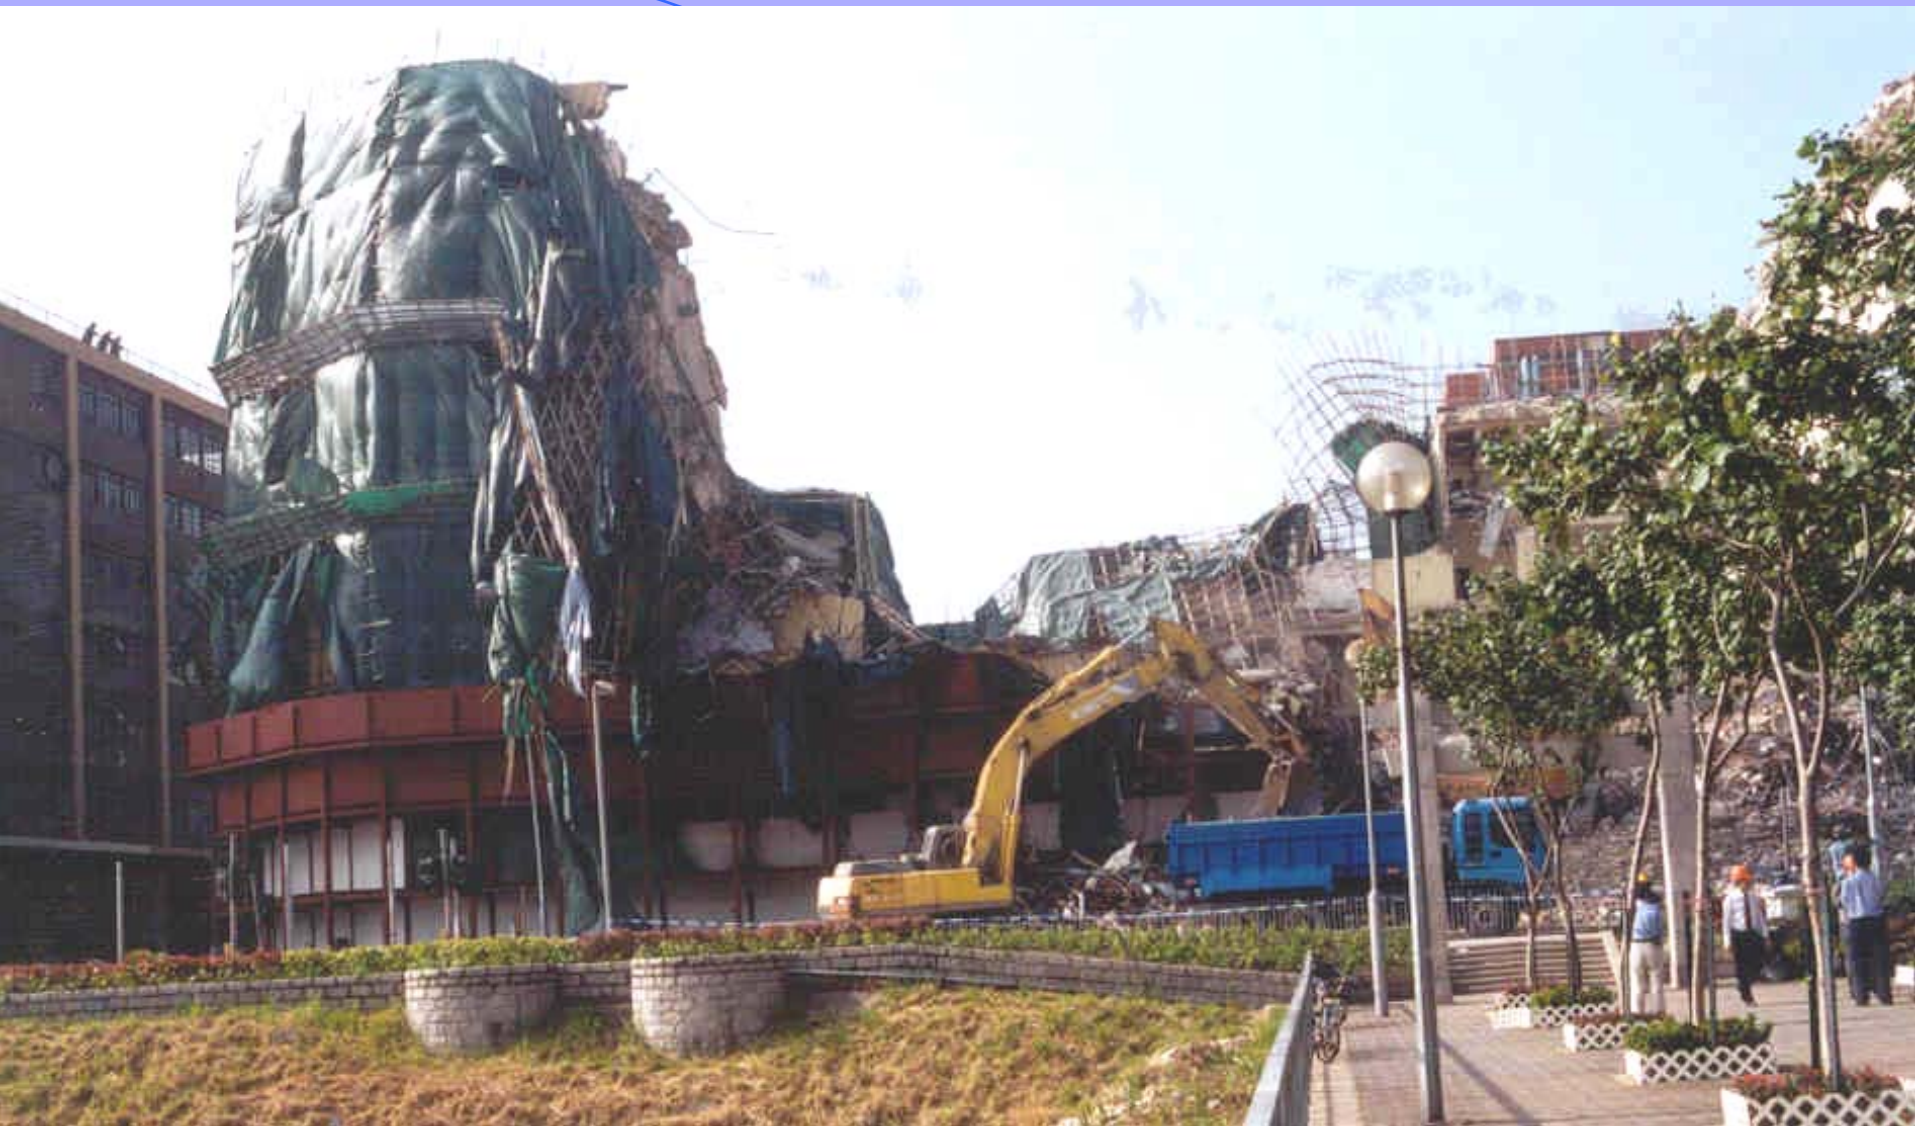
The site as seen on 30.11.01 (viewing west)

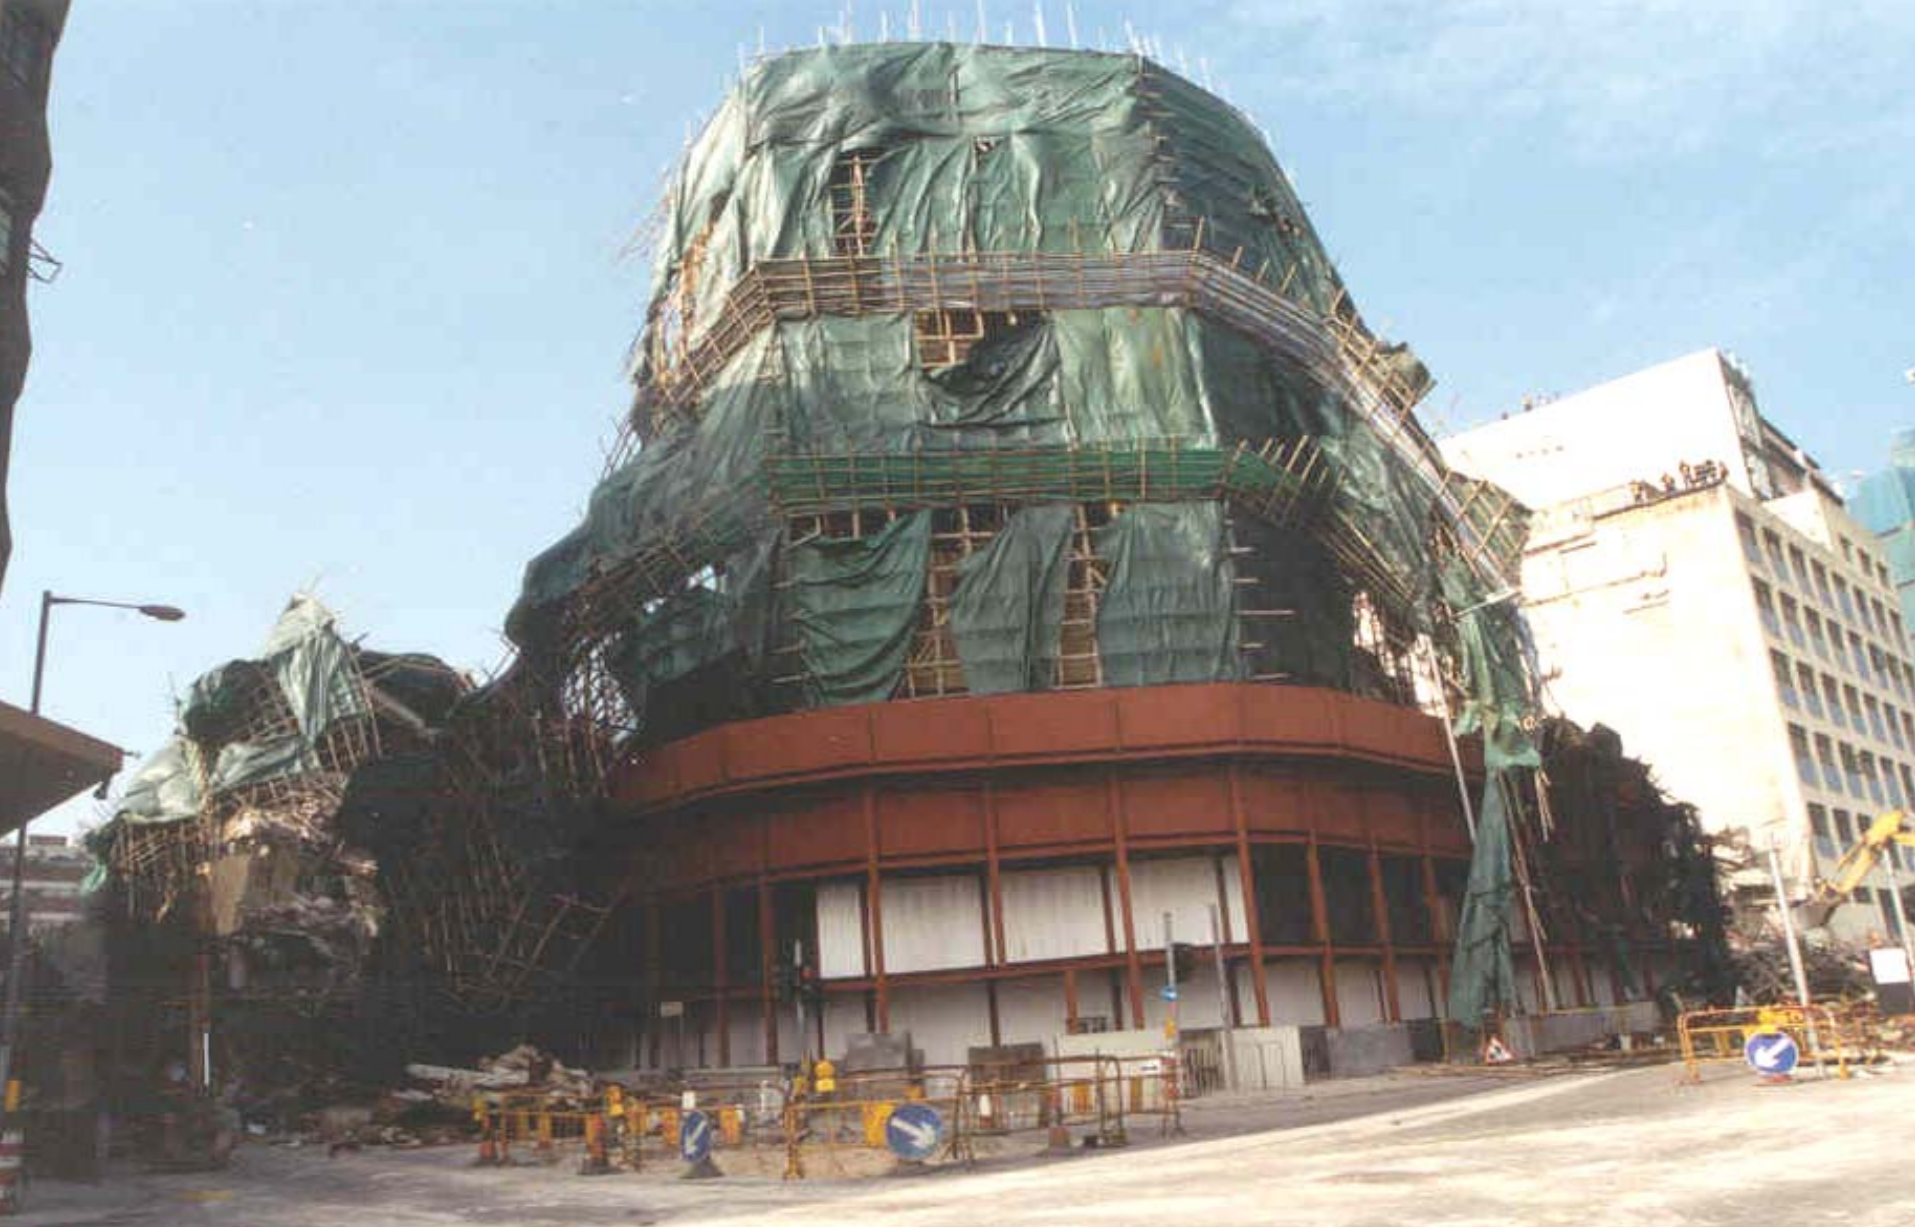
The site as seen on 30.11.01
(viewing at J/O Sze Shan Street and Shung Shun Street)

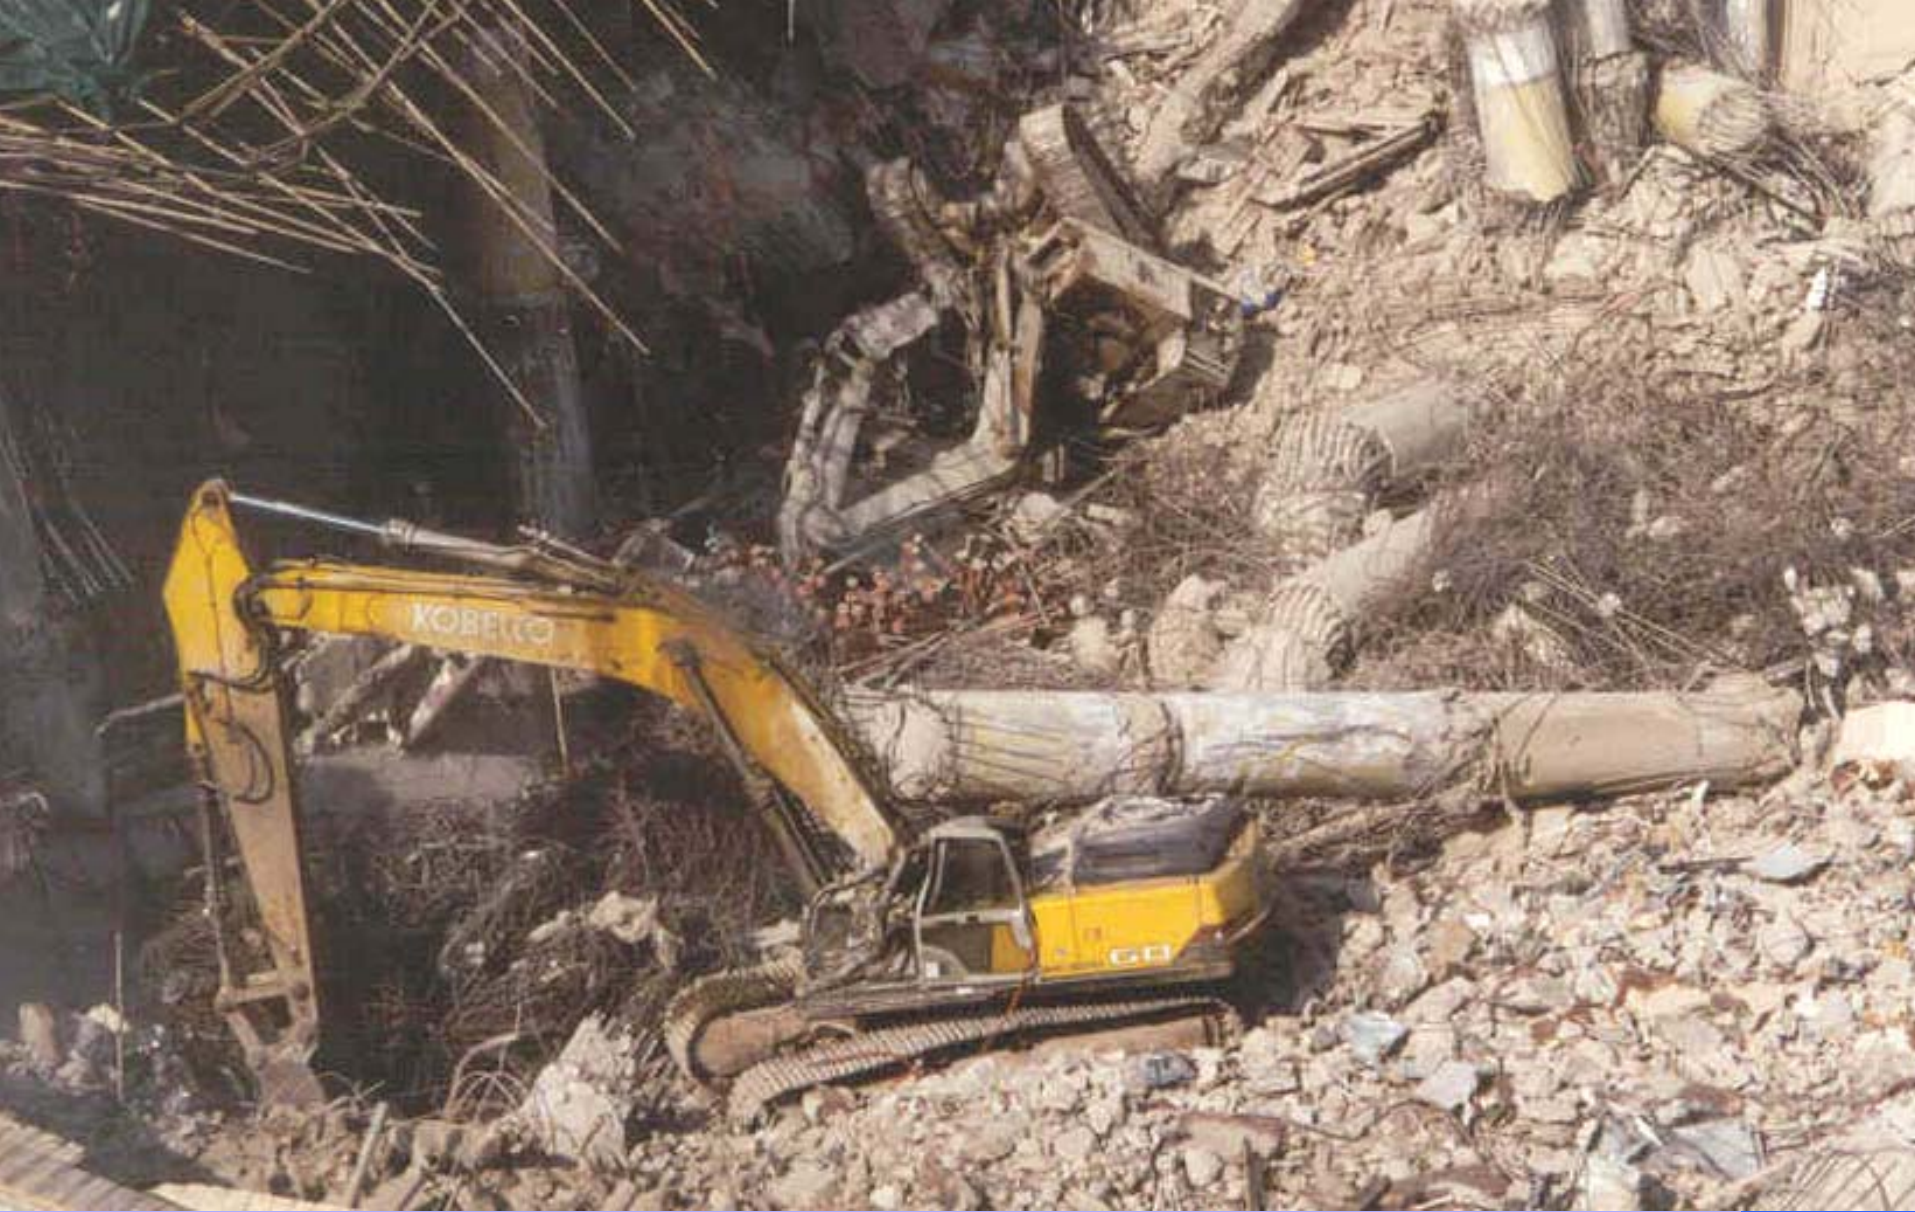
The damage – the wreck of two out of the five breaking/excavating machines used for demolition

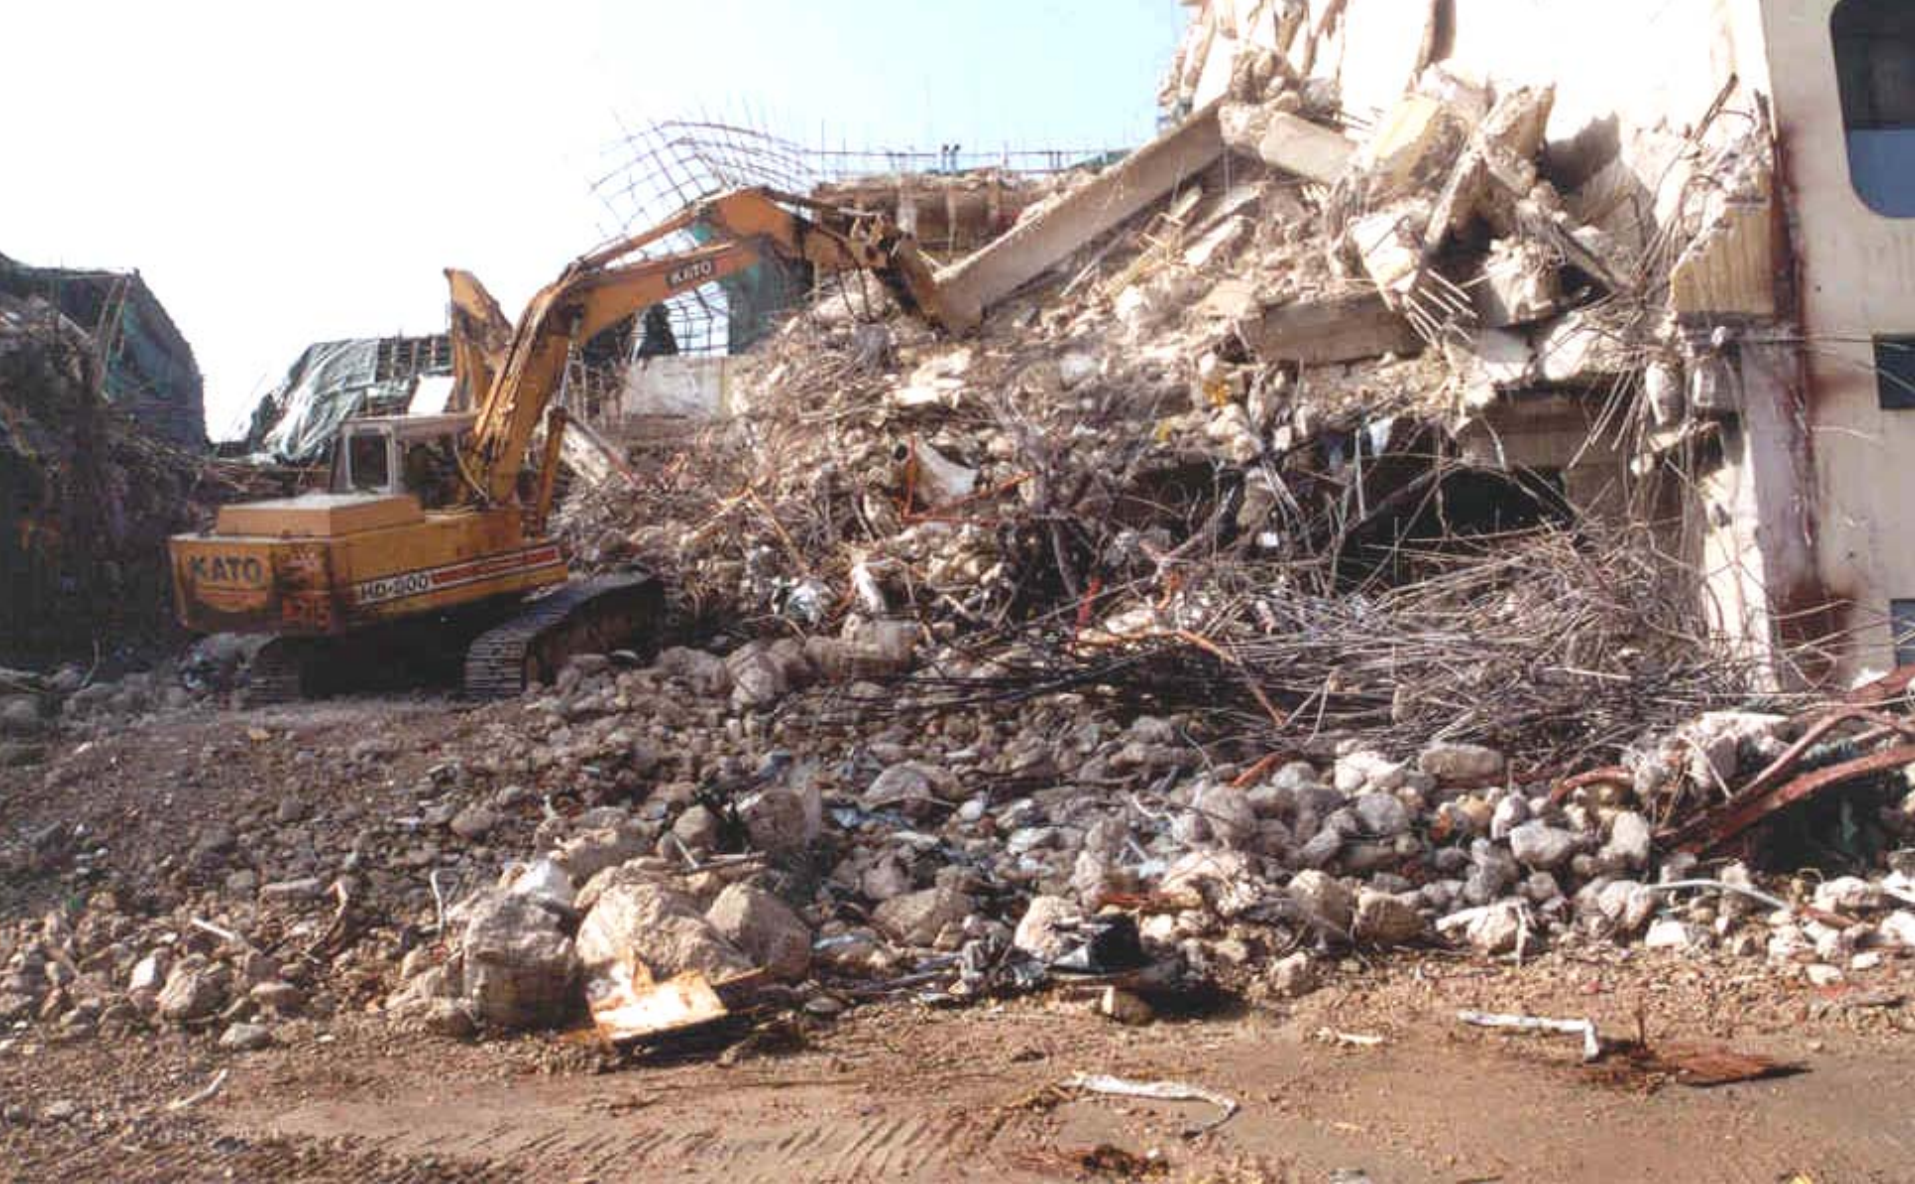
The damage – the 6-storey building collapsed inward forming a heap of debris about 6m high from ground

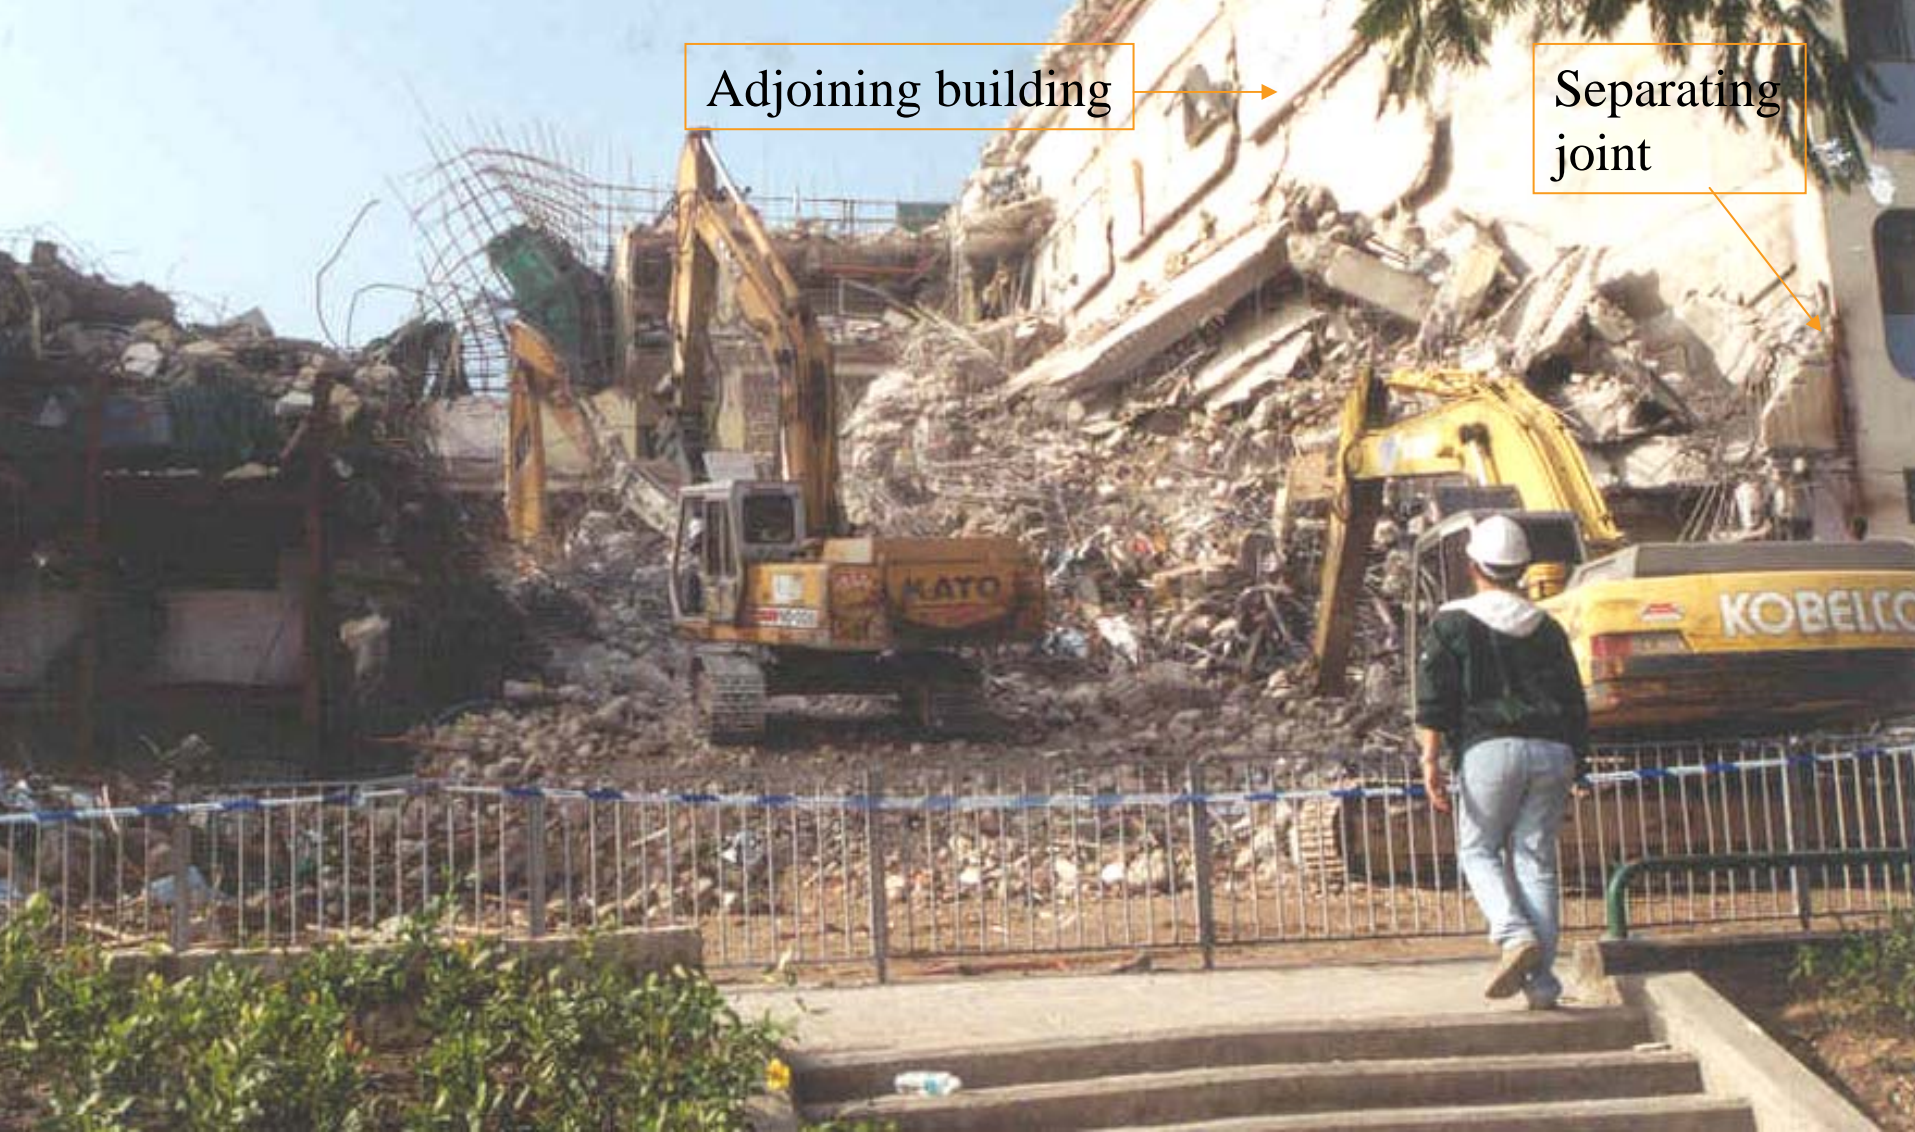
The damage – fortunately, the collapse does not damage the adjoining building which separated from the collapsed building by a separating joint only a few millimeter apart

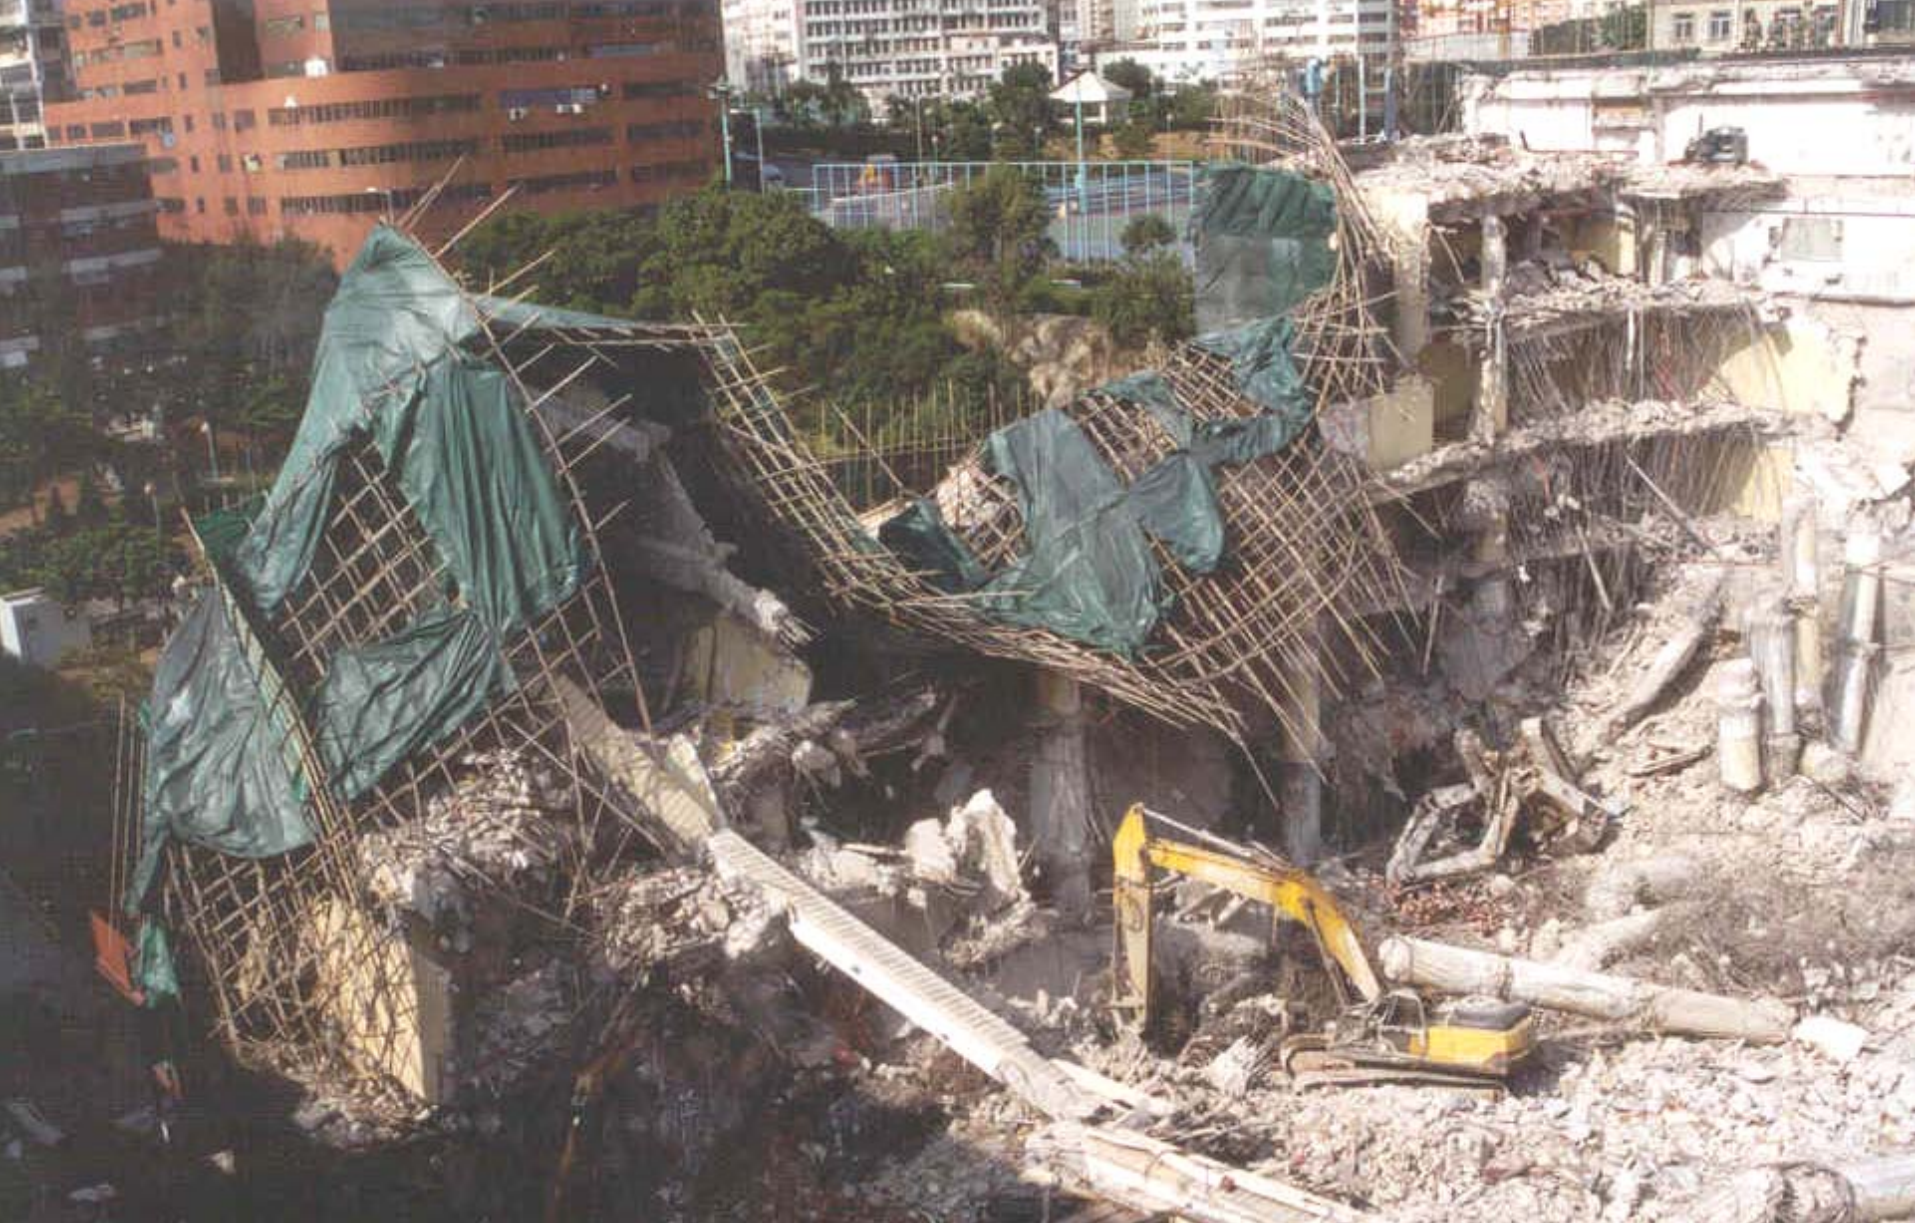
The remain – a section of the external wall on the west side of the building

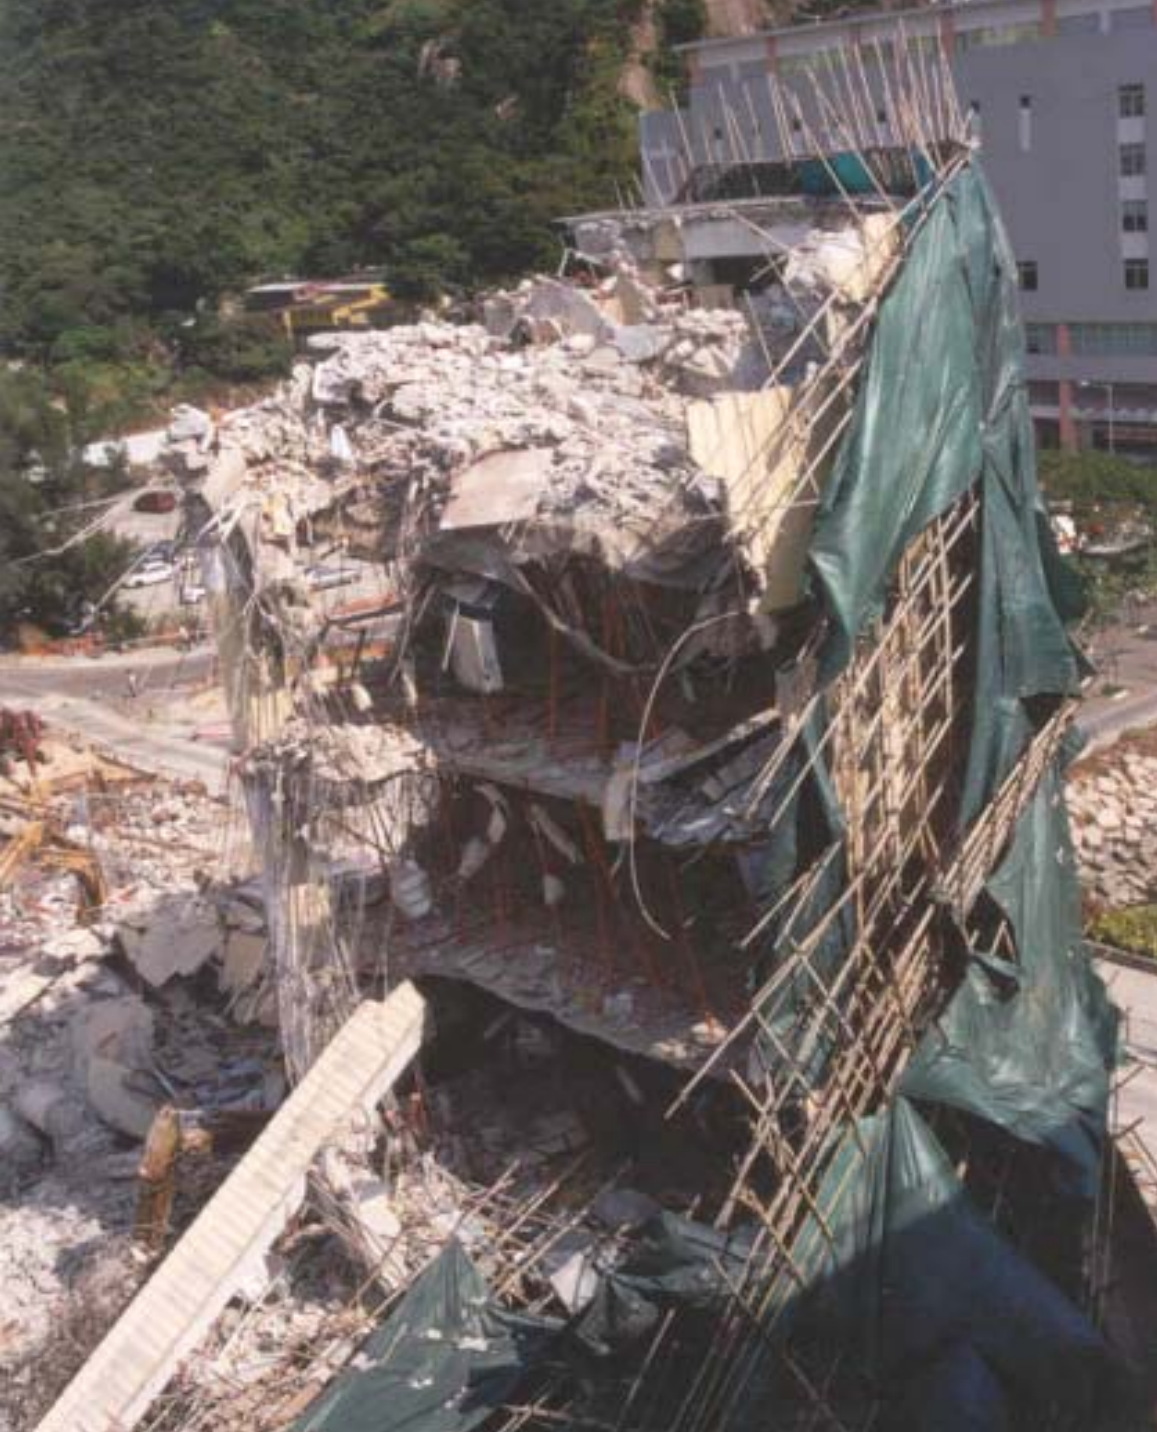
The remain – a
portion of building
structure at the
corner at J/O Sze
Shan Street &
Shung Shun Street

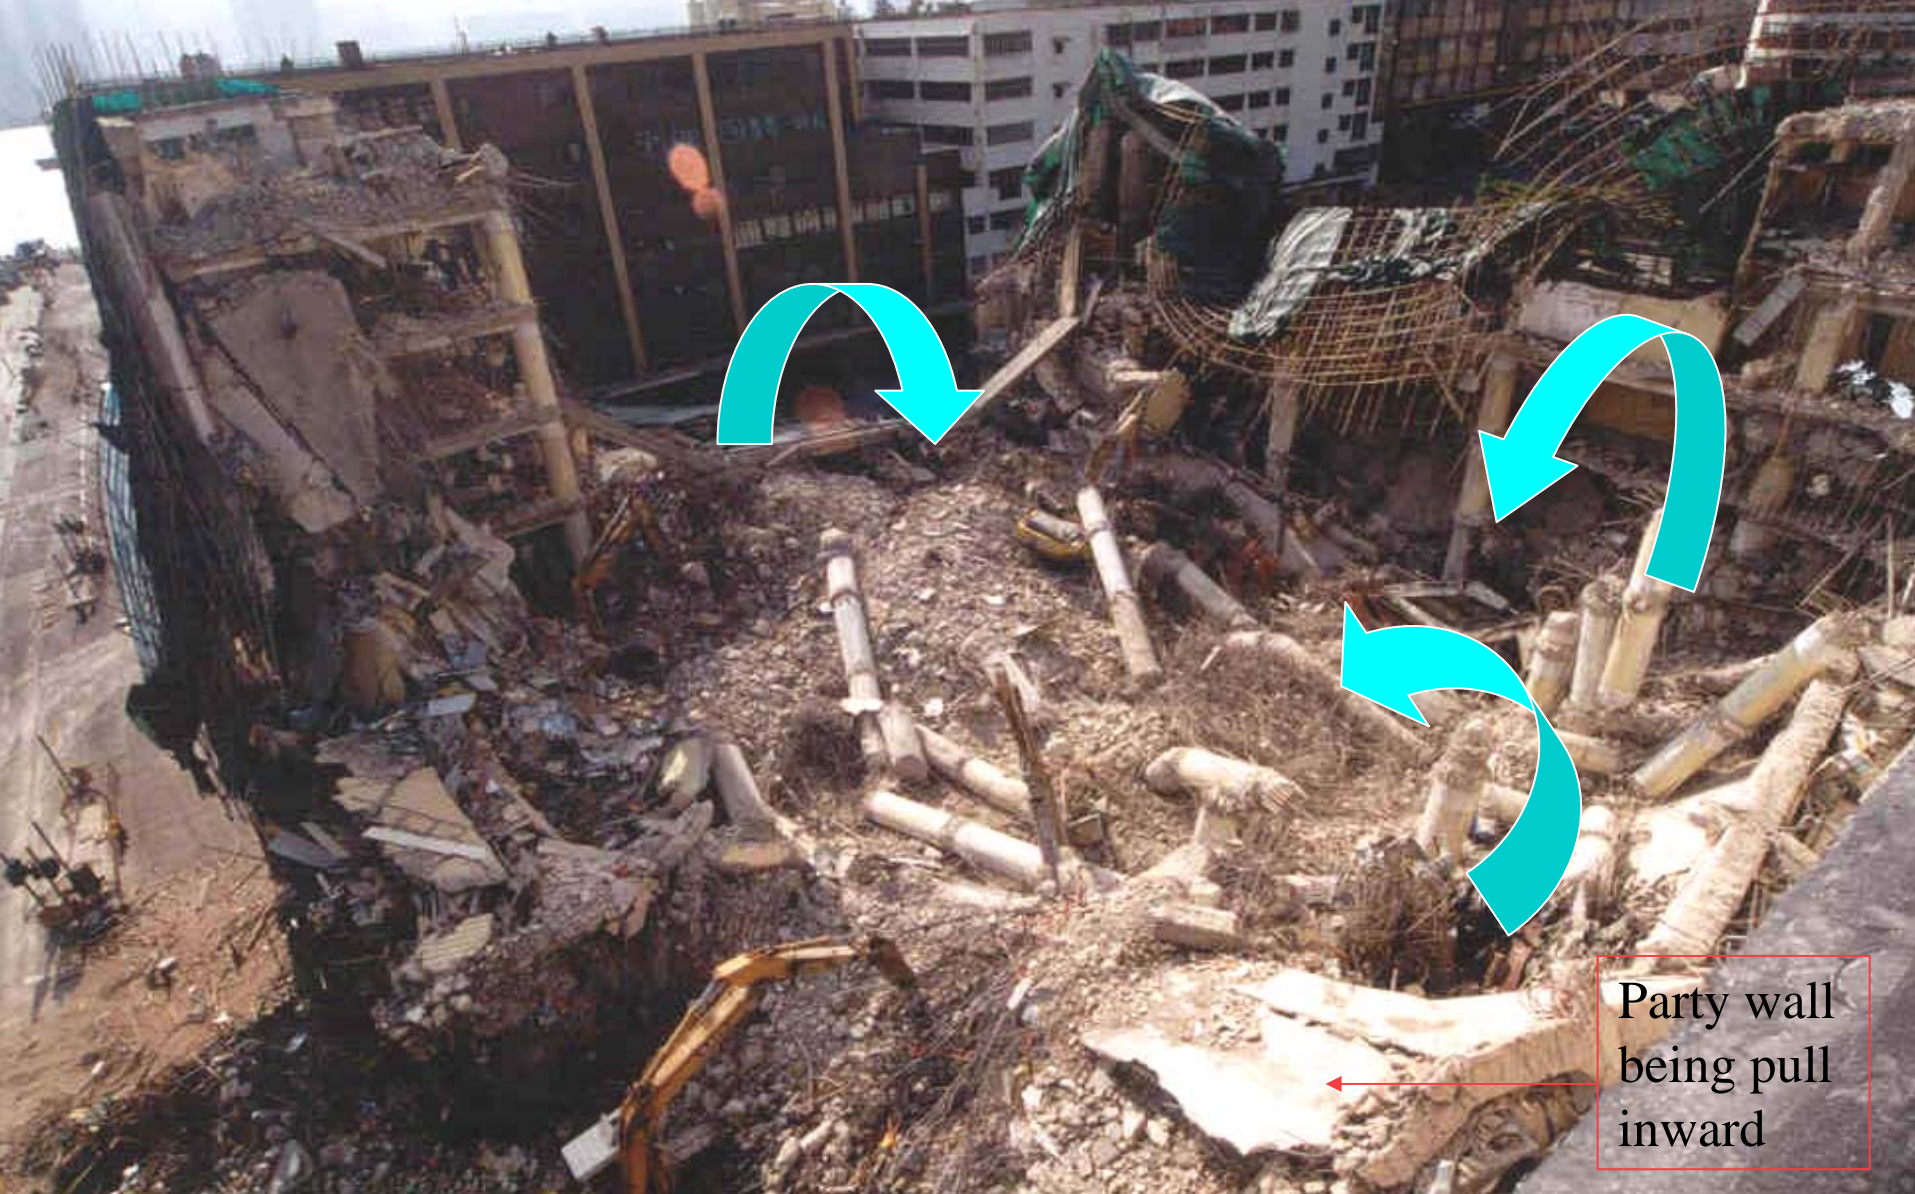
Observation – all the fallen columns centered inward indicates that the collapse orientated somewhat from the building center
