Demolition in Urban Environment

The Asian Trade Centre Case – an accident occurred in a demolishing building in Yau Tong on 29 Nov 2001

Presented by
Raymond Wong

Division of Building Science & Technology

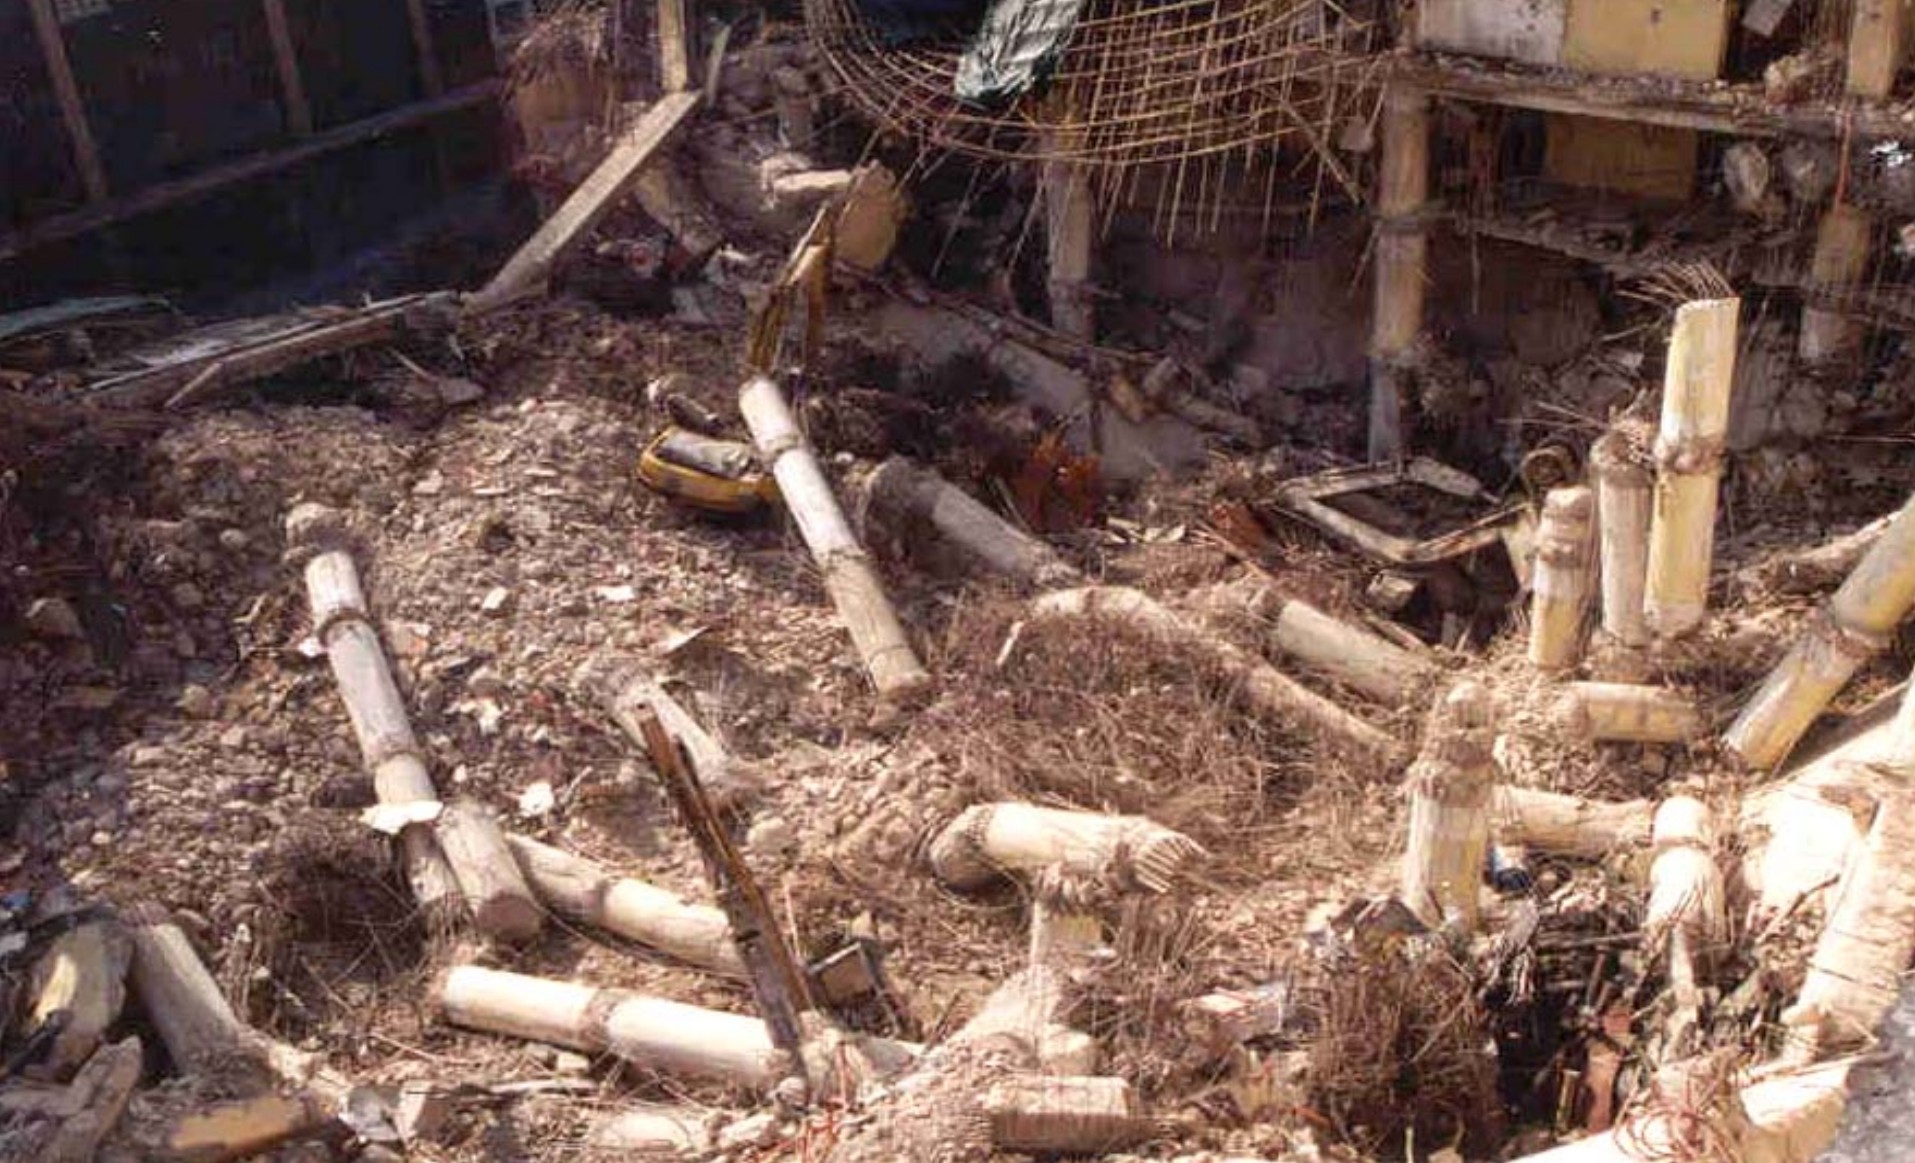
Observation – with the columns basically remain intact while no trace of floor slab can be observed in the remain indicates that the floor structure in general is a weak source that may cause the collapse

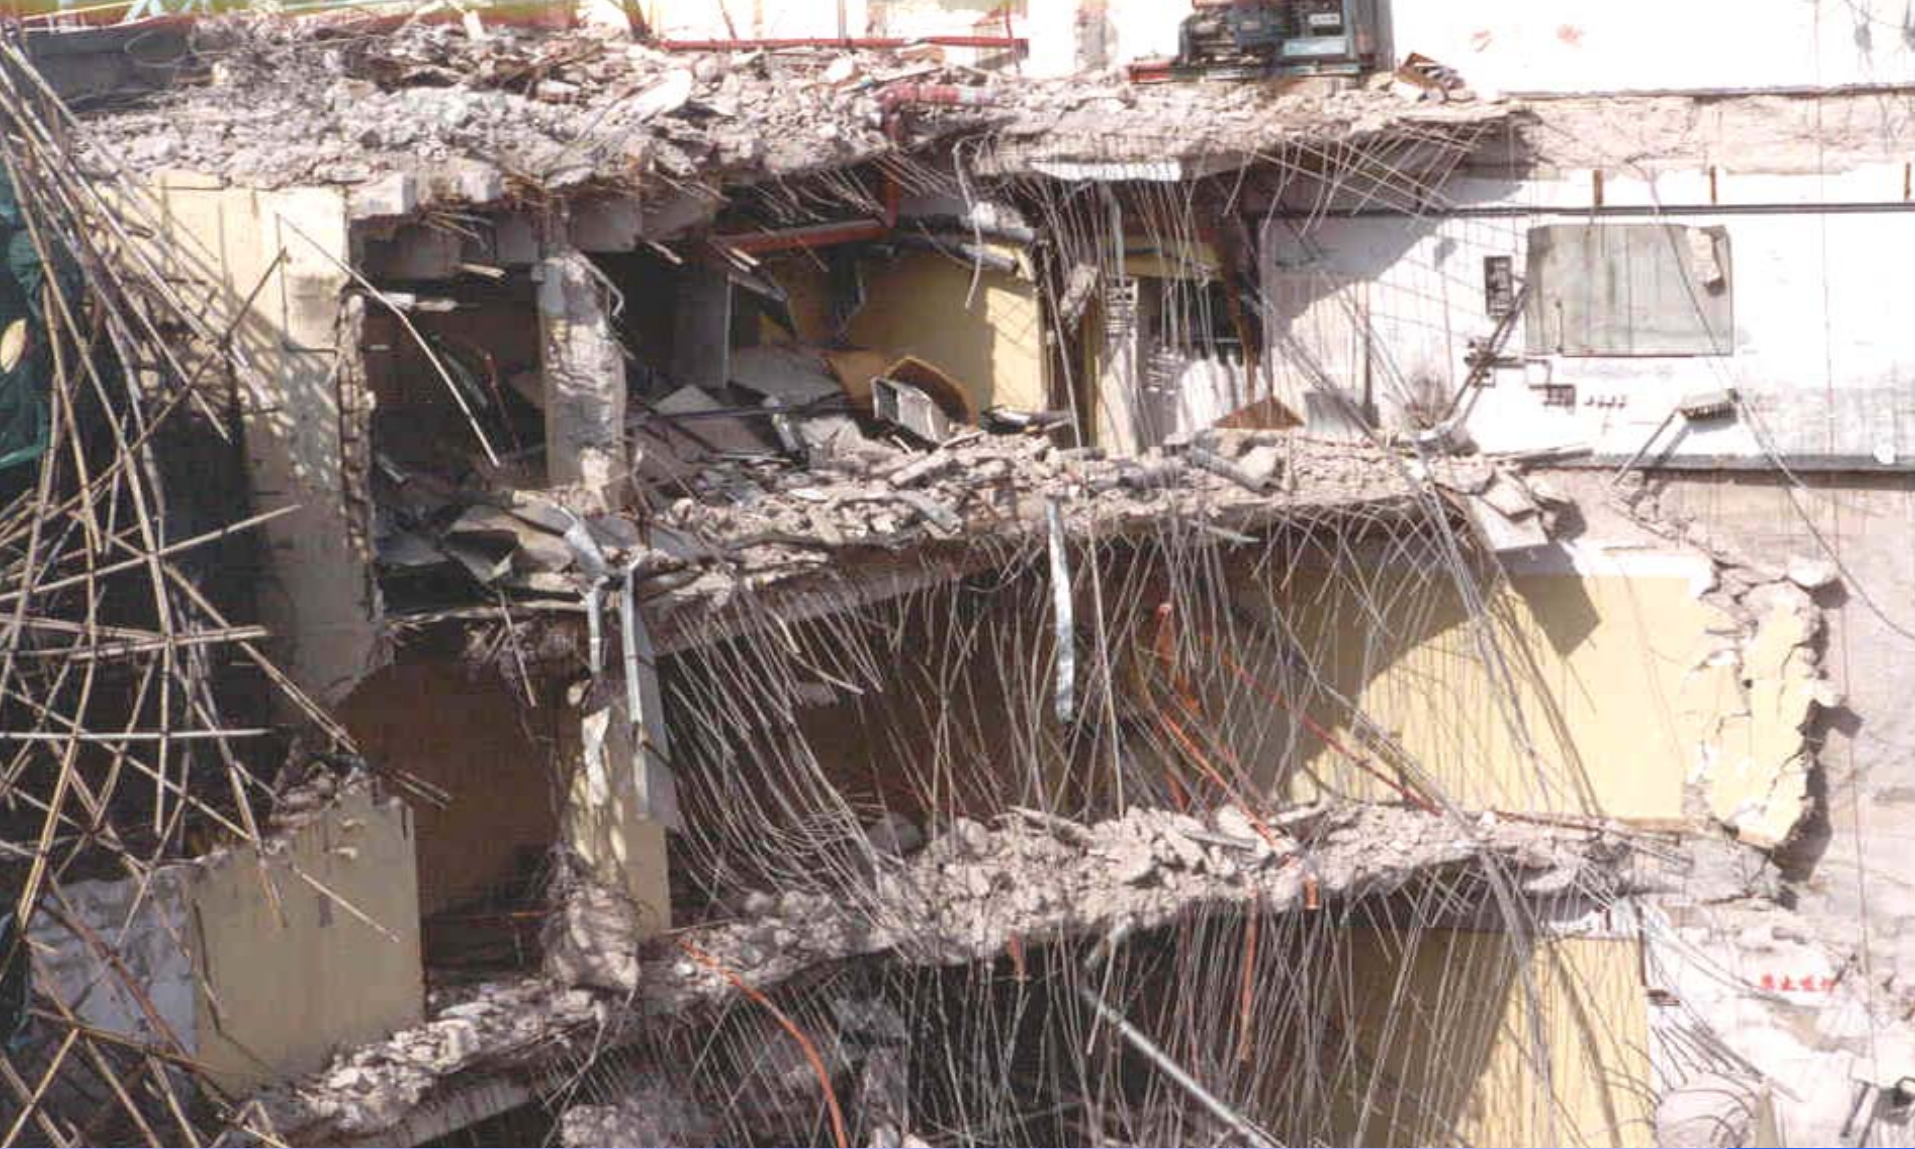
Observation – the exposed steel bars on the cut-edges indicates the collapsing structure fell rapidly and produced tremendous pulling force that fail to keep the floor in position. There is no trace of floor concrete adhered to the bar, again indicates that strength of concrete may be sub-standard

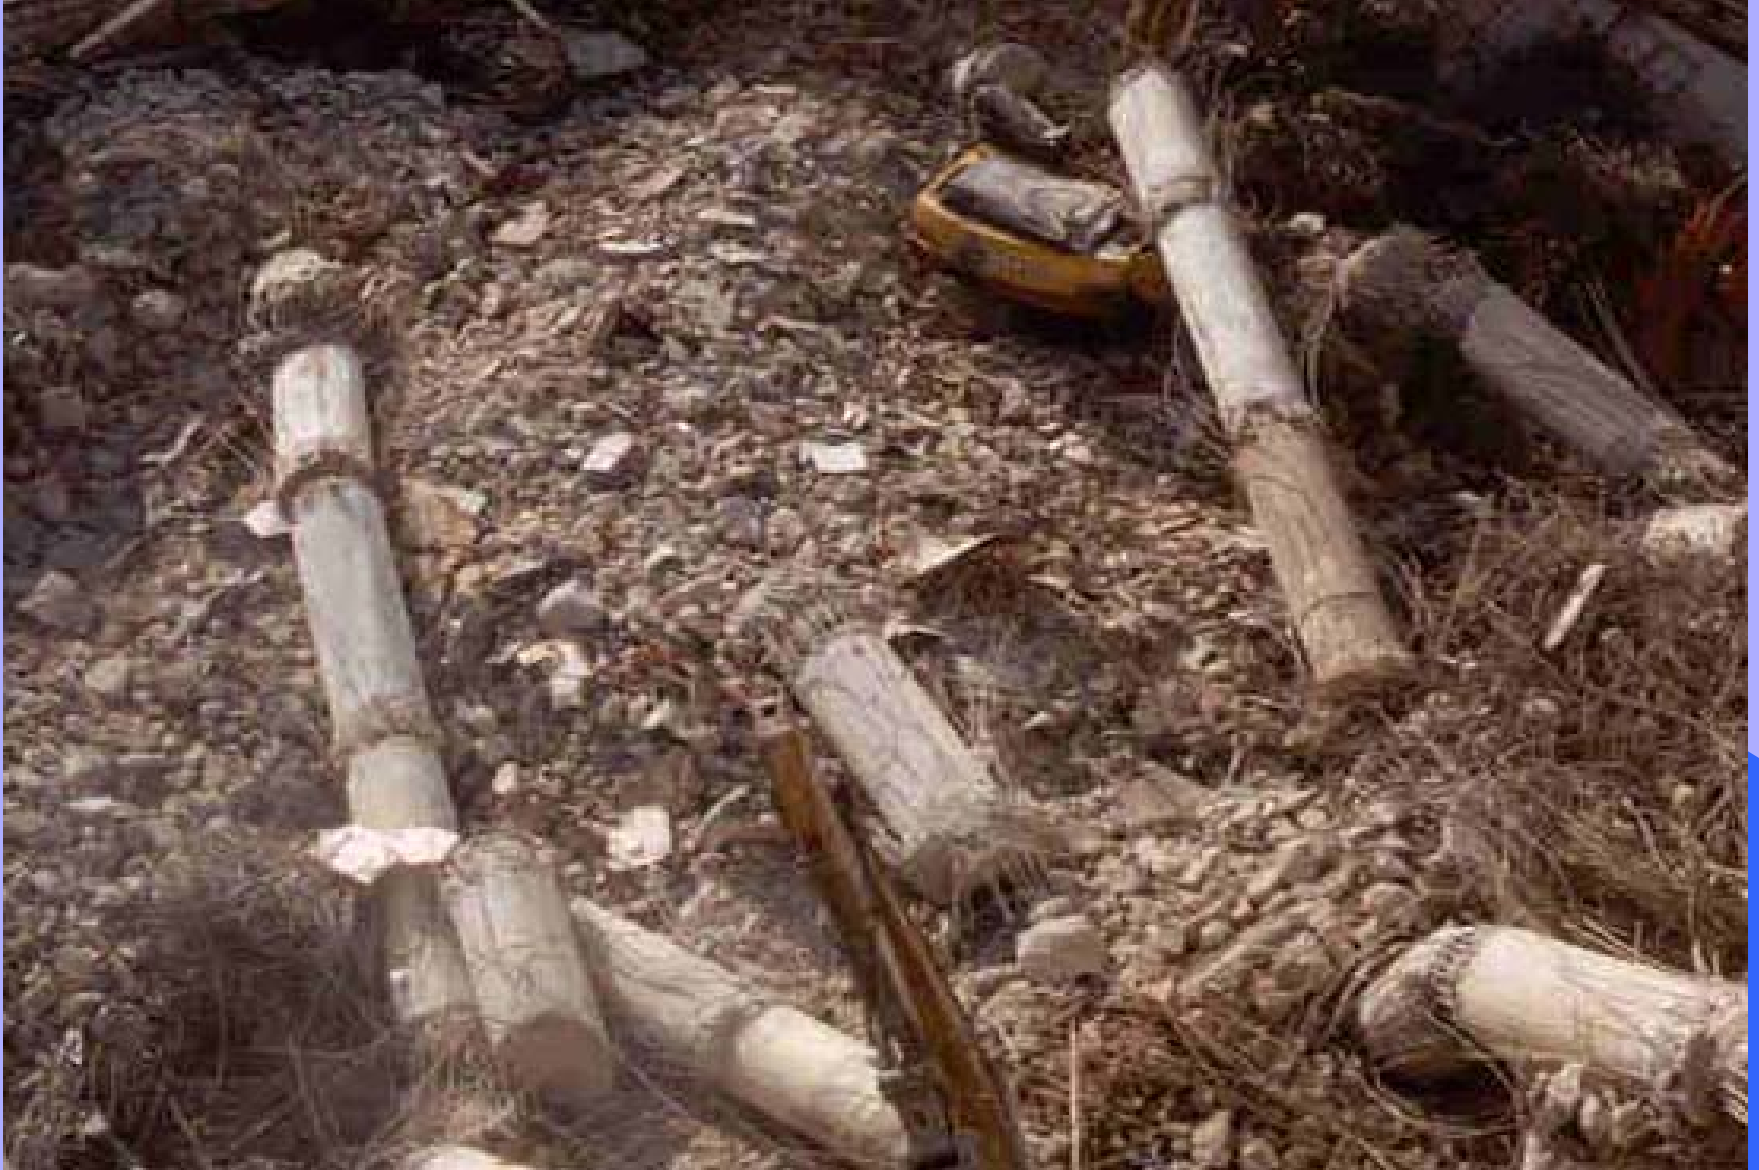
Observation – further evidence of possible floor failure.
More than 3 storeys of floor slab crushed to rubble and detached completely from the columns

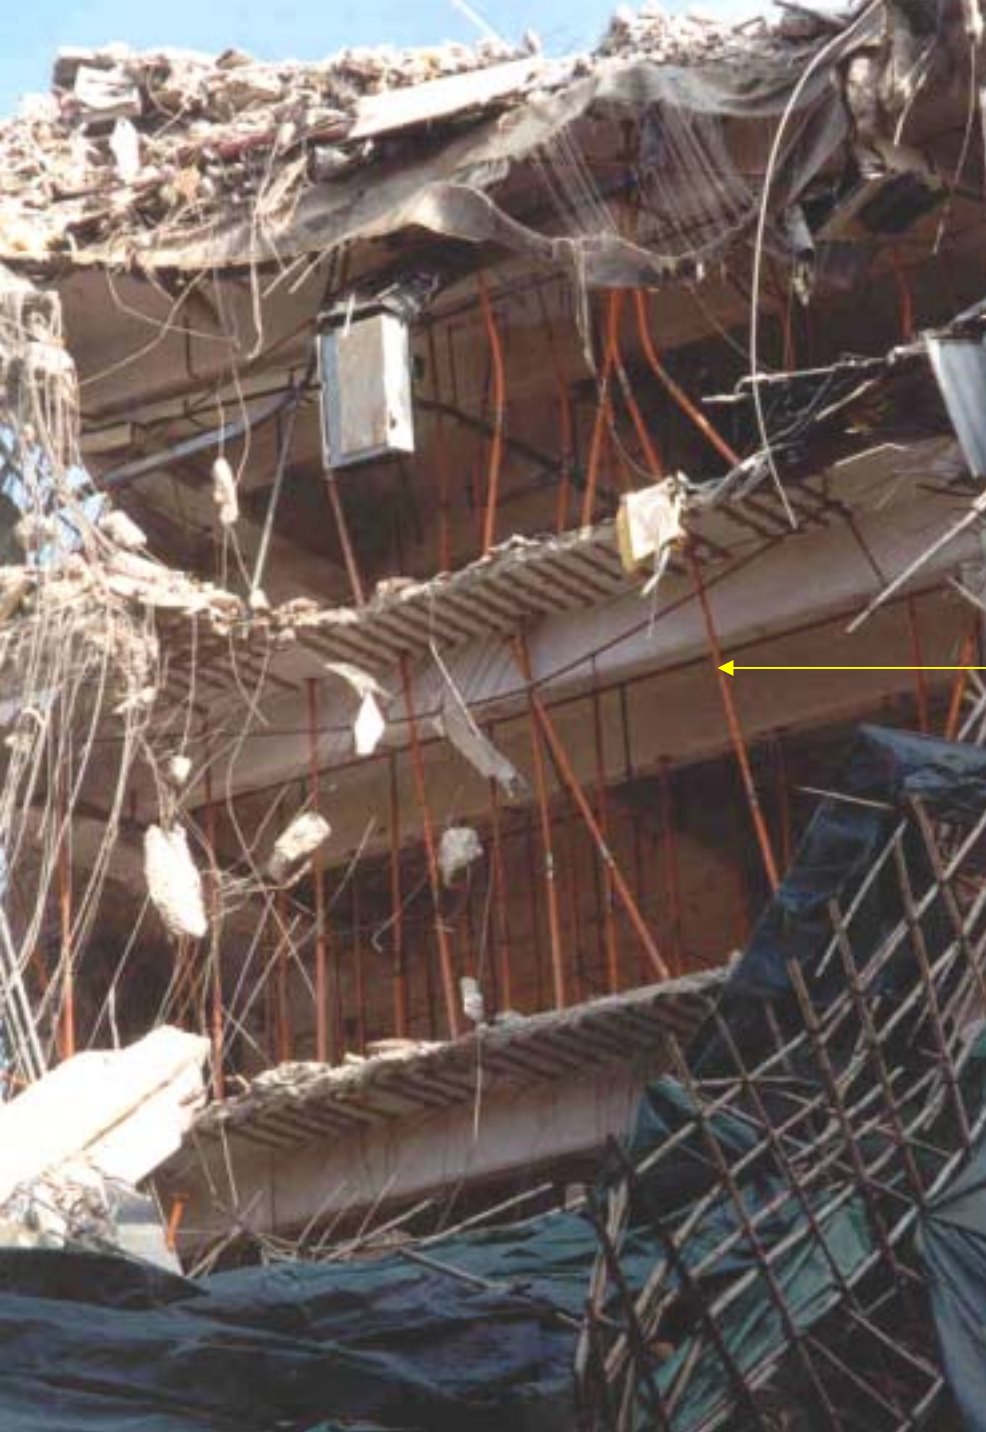
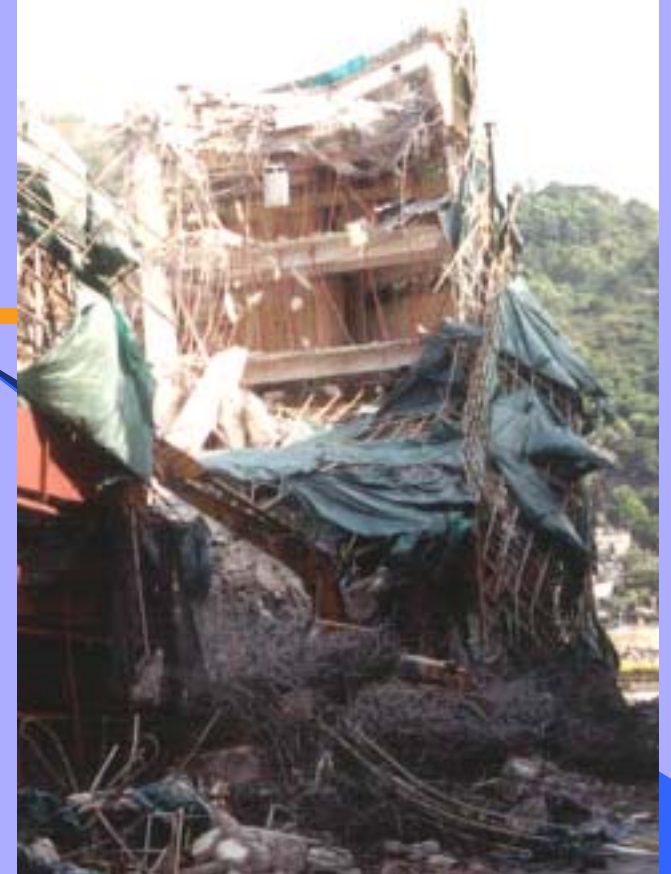
Steel
prop

Observation – the steel props used as temporary support for the positioning of the heavy breaker machines seem insufficient for the purpose

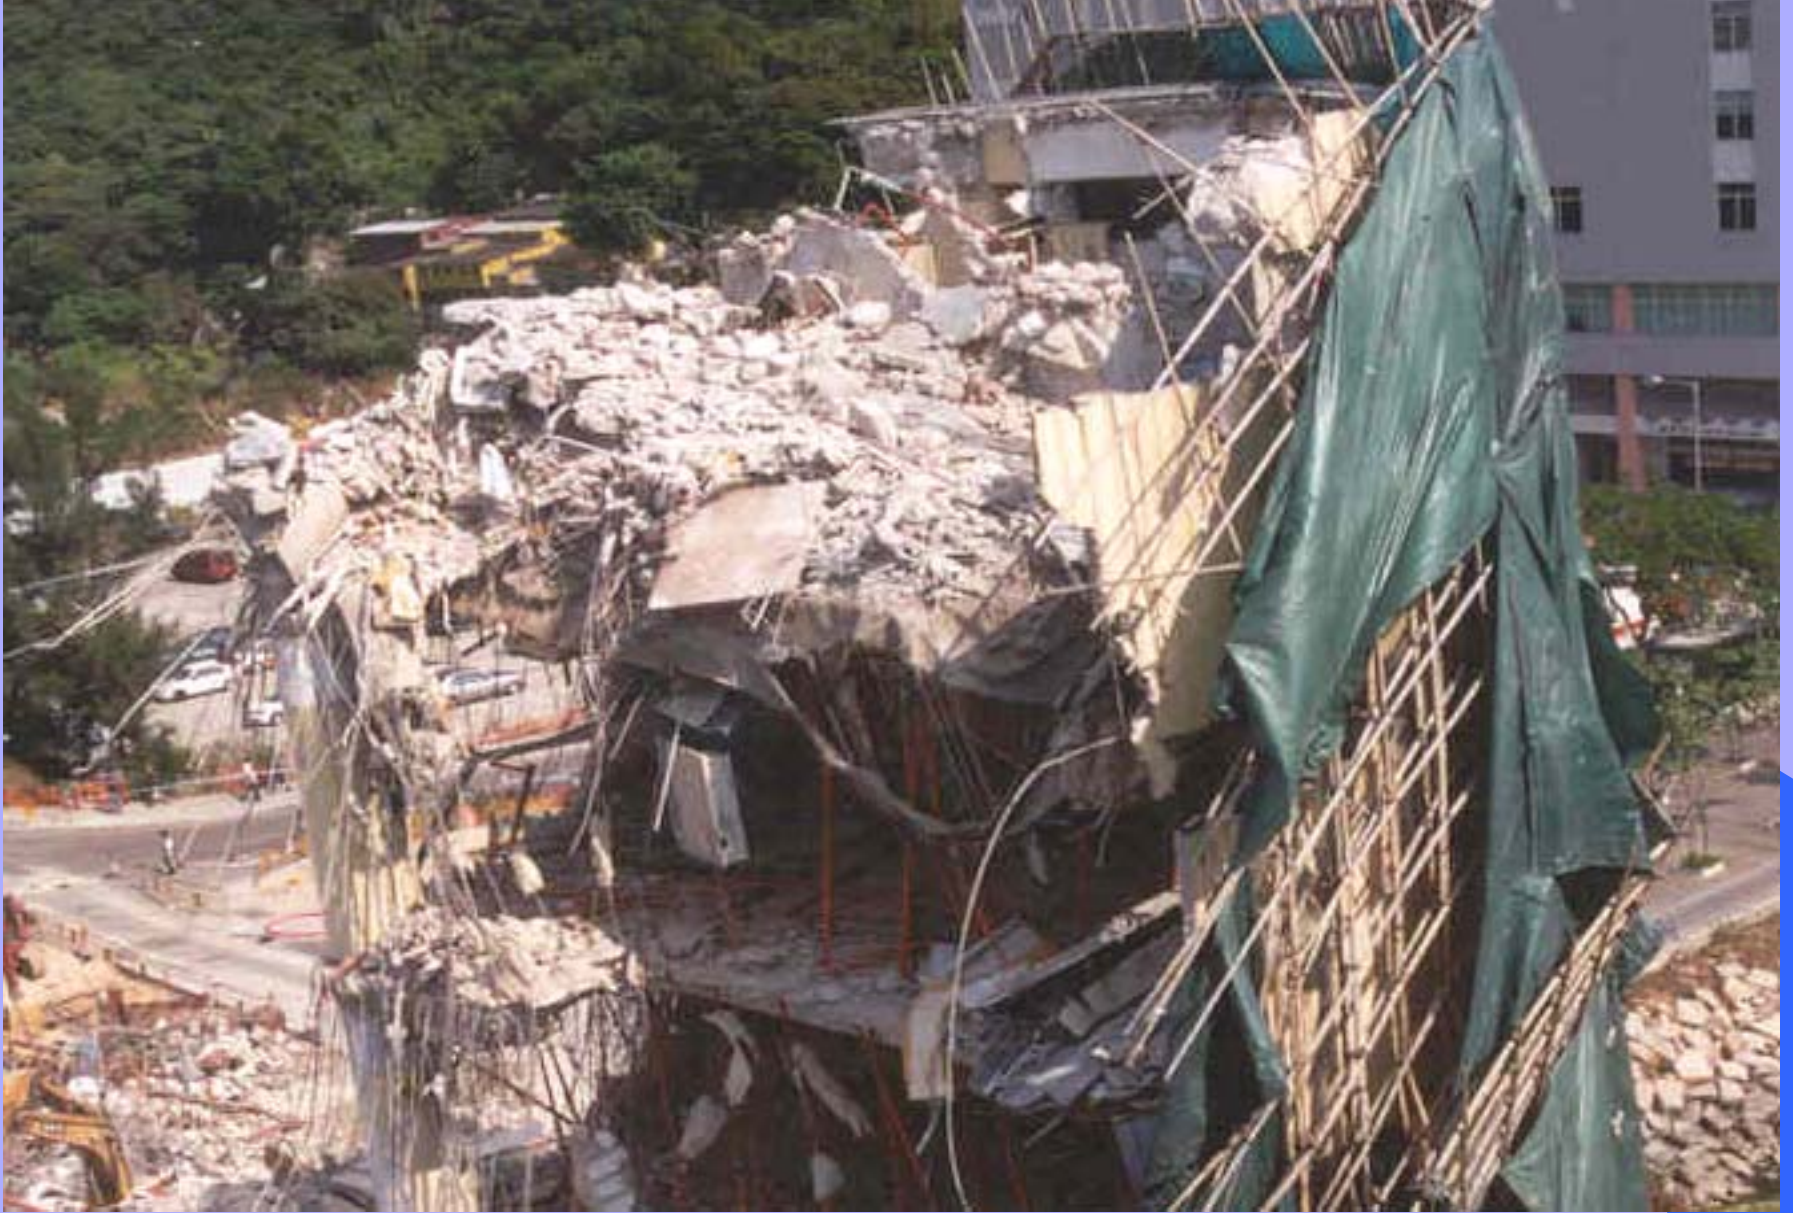
Observation – the accommodation of large amount of debris above the floor impose great loads to the structure
